LAKE QUINN DAM

NDI ID NO. PA-00145

PHASE I INSPECTION REPORT NATIONAL DAM INSPECTION PROGRAM

(11) February 1981

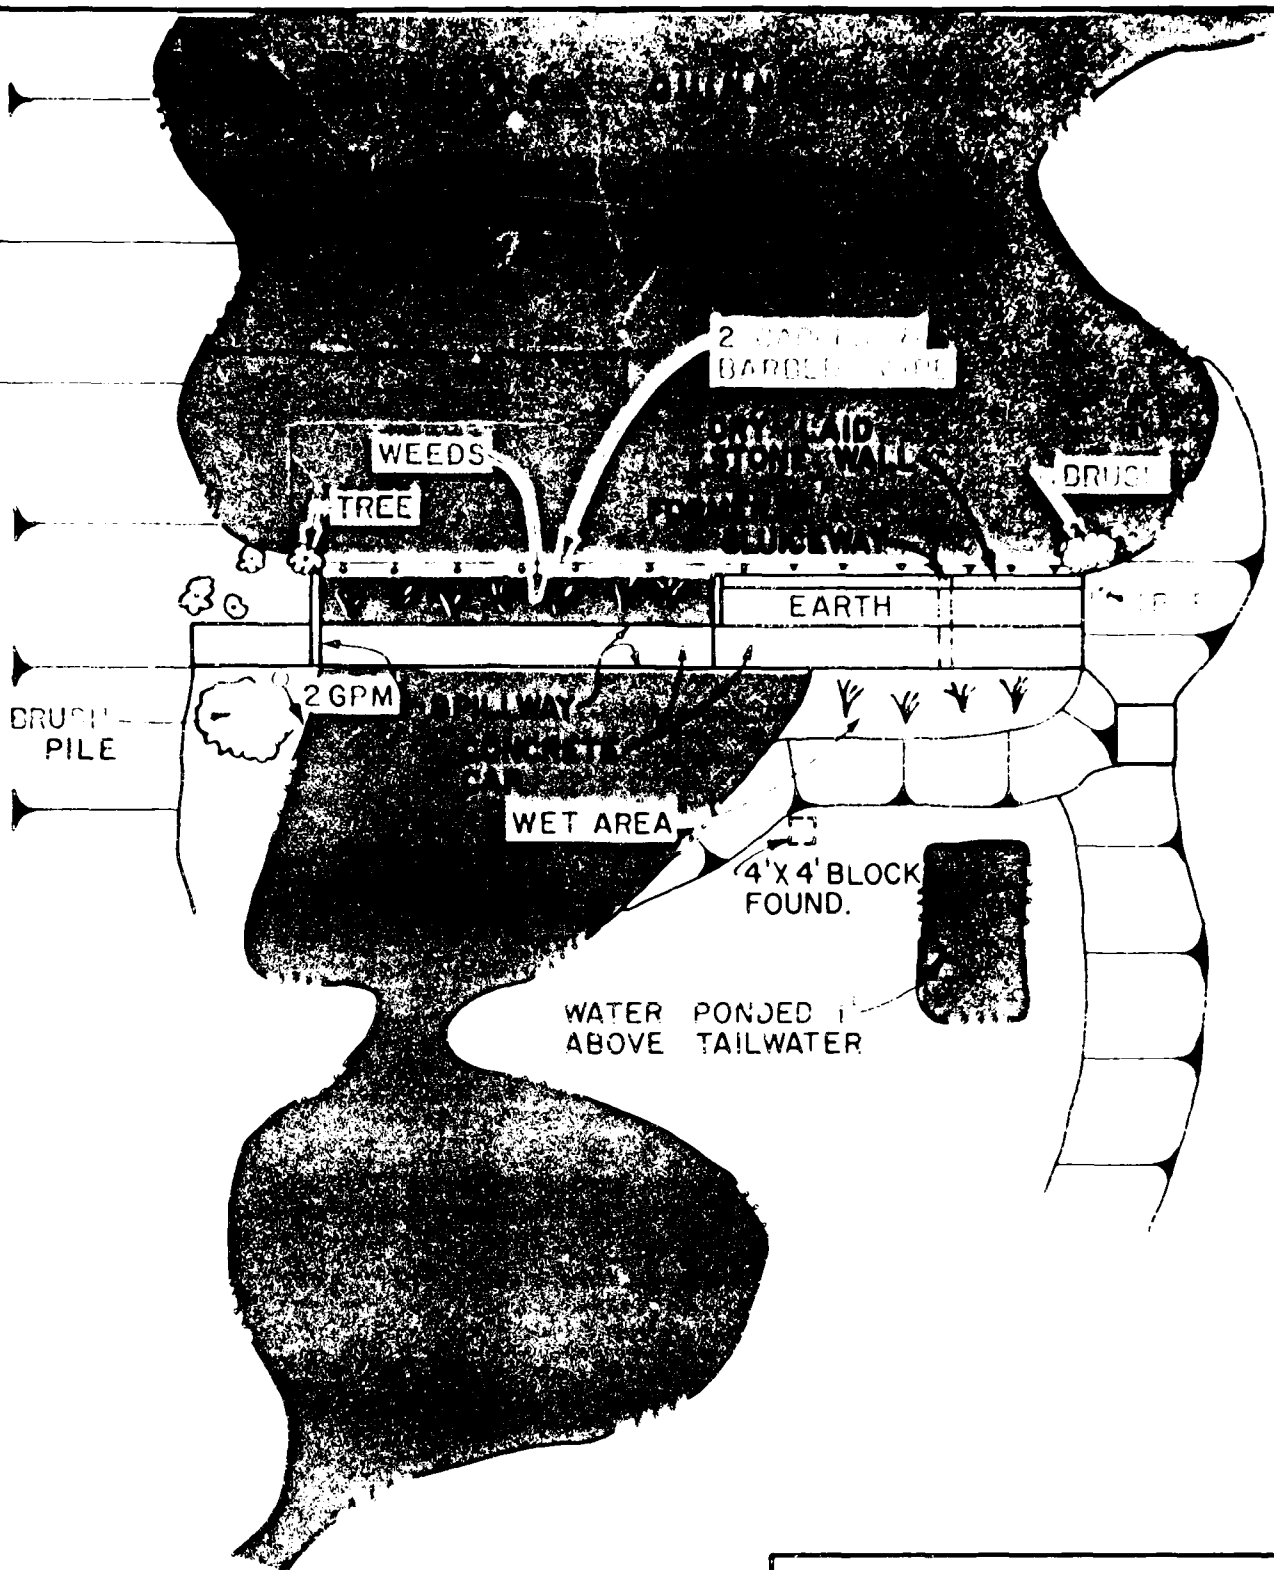
EXHIBIT A-1

Clear seepage is flowing at approximately 2 gpm from the downstream face about four feet below the crest and four feet to the right of the spillway. A pile of recently cut brush and small tree limbs obscures this area of the downstream face. Immediately downstream of the toe at the left end of the dam is an area of standing water. It is apparent from the type of vegetation that this area is usually wet. Inspection reports beginning in 1938 note that some seepage was observed at the right abutment and at the hillside on the left abutment. The area downstream of the toe of the overflow section is submerged by tailwater.

2 GPM

INDICATES LOCATION AND
QUANTITY OF SEEPAGE

C. The seepage, near the right abutment should be monitored and appropriate remedial action taken should the condition begin to worsen significantly.
